# Army Lodging Wellness Recommendation

## Final Submittal - Tooele Army Depot

April 30, 2004

# Tooele Army Depot

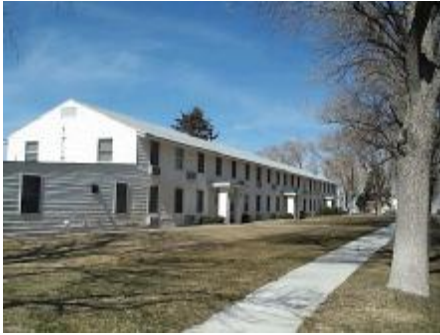
*Building 35  
Headquarters Loop  
Tooele, Utah*

Building 35, constructed in 1942, is a wood frame structure housing 11 oversized family suites. This building is in poor condition and does not meet the Lodging size requirements or provide appropriate support spaces. The cost to make condition assessment improvements to this facility will exceed 50% of the replacement cost.

• Condition Assessment Cost	\$887,192
• Replacement Cost	\$1,359,000
• Condition Assessment to Replacement Cost Ratio	65.28%

Because the Condition Assessment to Replacement Cost Ratio is greater than 50.00%, repair of Building 35 is not recommended.

Our recommendation is to remove building 35 from the Lodging inventory, allowing the installation to determine an alternate use for this facility. This facility will be removed from the Tooele Army Depot Wellness Solution and Lodging Master Plan.

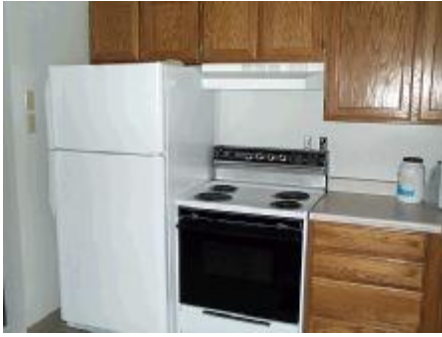
Building 35  
Typical kitchen

- Analysis: The guest room kitchen units consist of a sink, microwave oven, a 4 burner stove with oven, and a refrigerator. The refrigerators and microwave ovens were replaced in 2003 and are in new conditions. The stoves with ovens and sink with disposals were installed in 1990. The stoves are scheduled for replacement this year.
- Recommendation: Replace sinks in conjunction with the plumbing replacement.
